Navajo Abandoned Uranium Mine

Site Screen Report

Mine Name: Claim 16
Mine ID: 806

August 2011

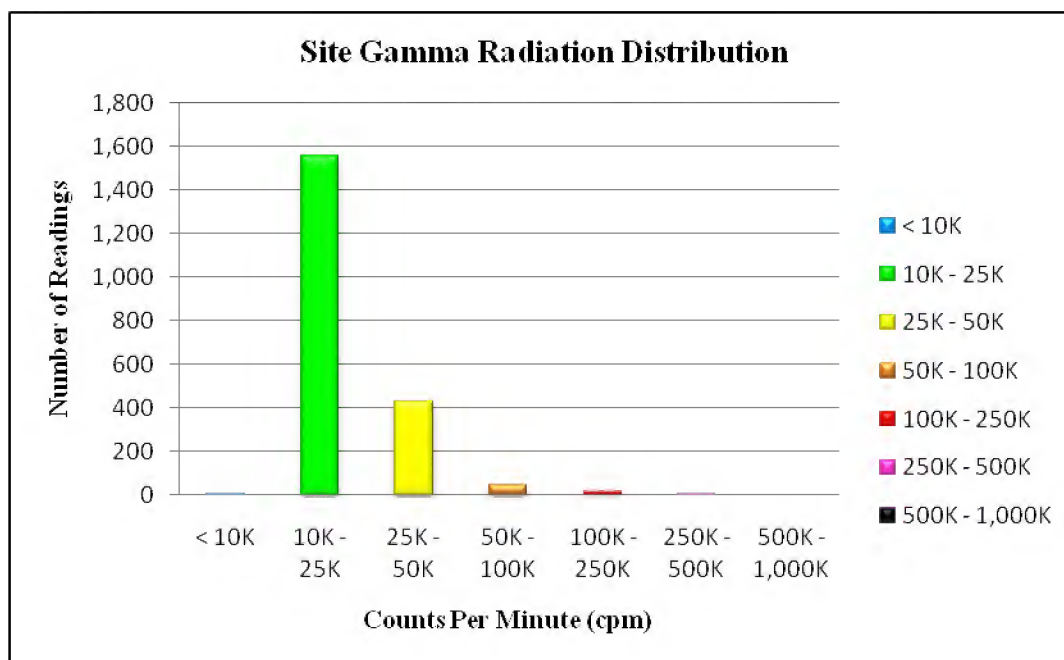
Distribution Chart and Statistics:

Site Gamma Radiation Statistics

Number of Readings	2,052
Minimum (cpm)	9,770
Maximum (cpm)	421,288
Mean (cpm)	23,838
Median (cpm)	19,912
Standard Deviation	17,379

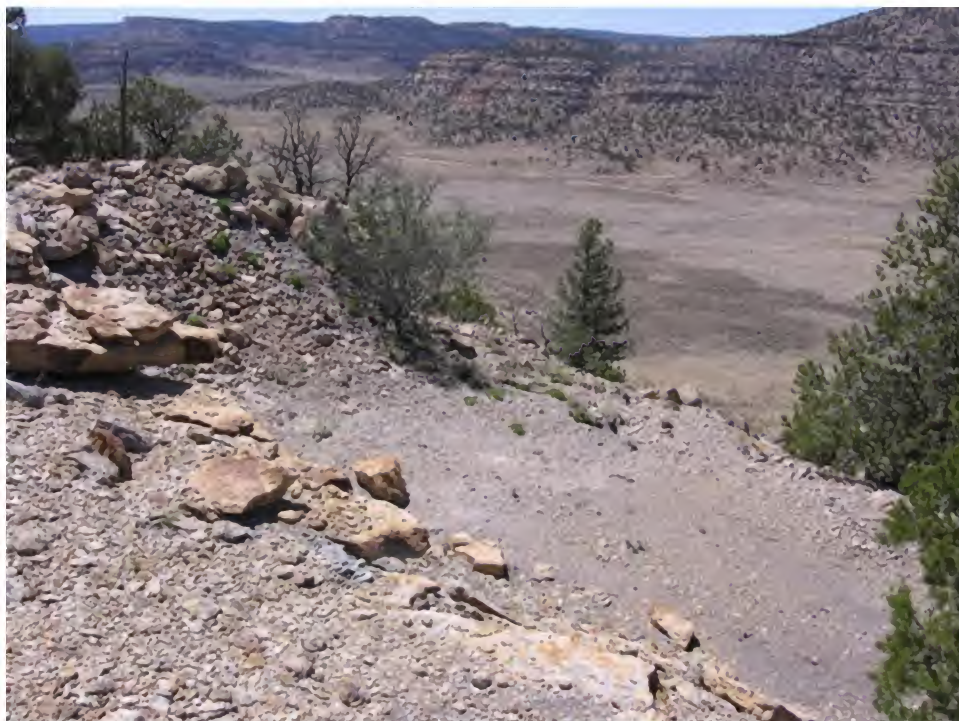
Small depression/pit, 20'x10' oval, gray shale soil, berm surrounding pit

Photo 4: Mine Site #806; Small pit / workings

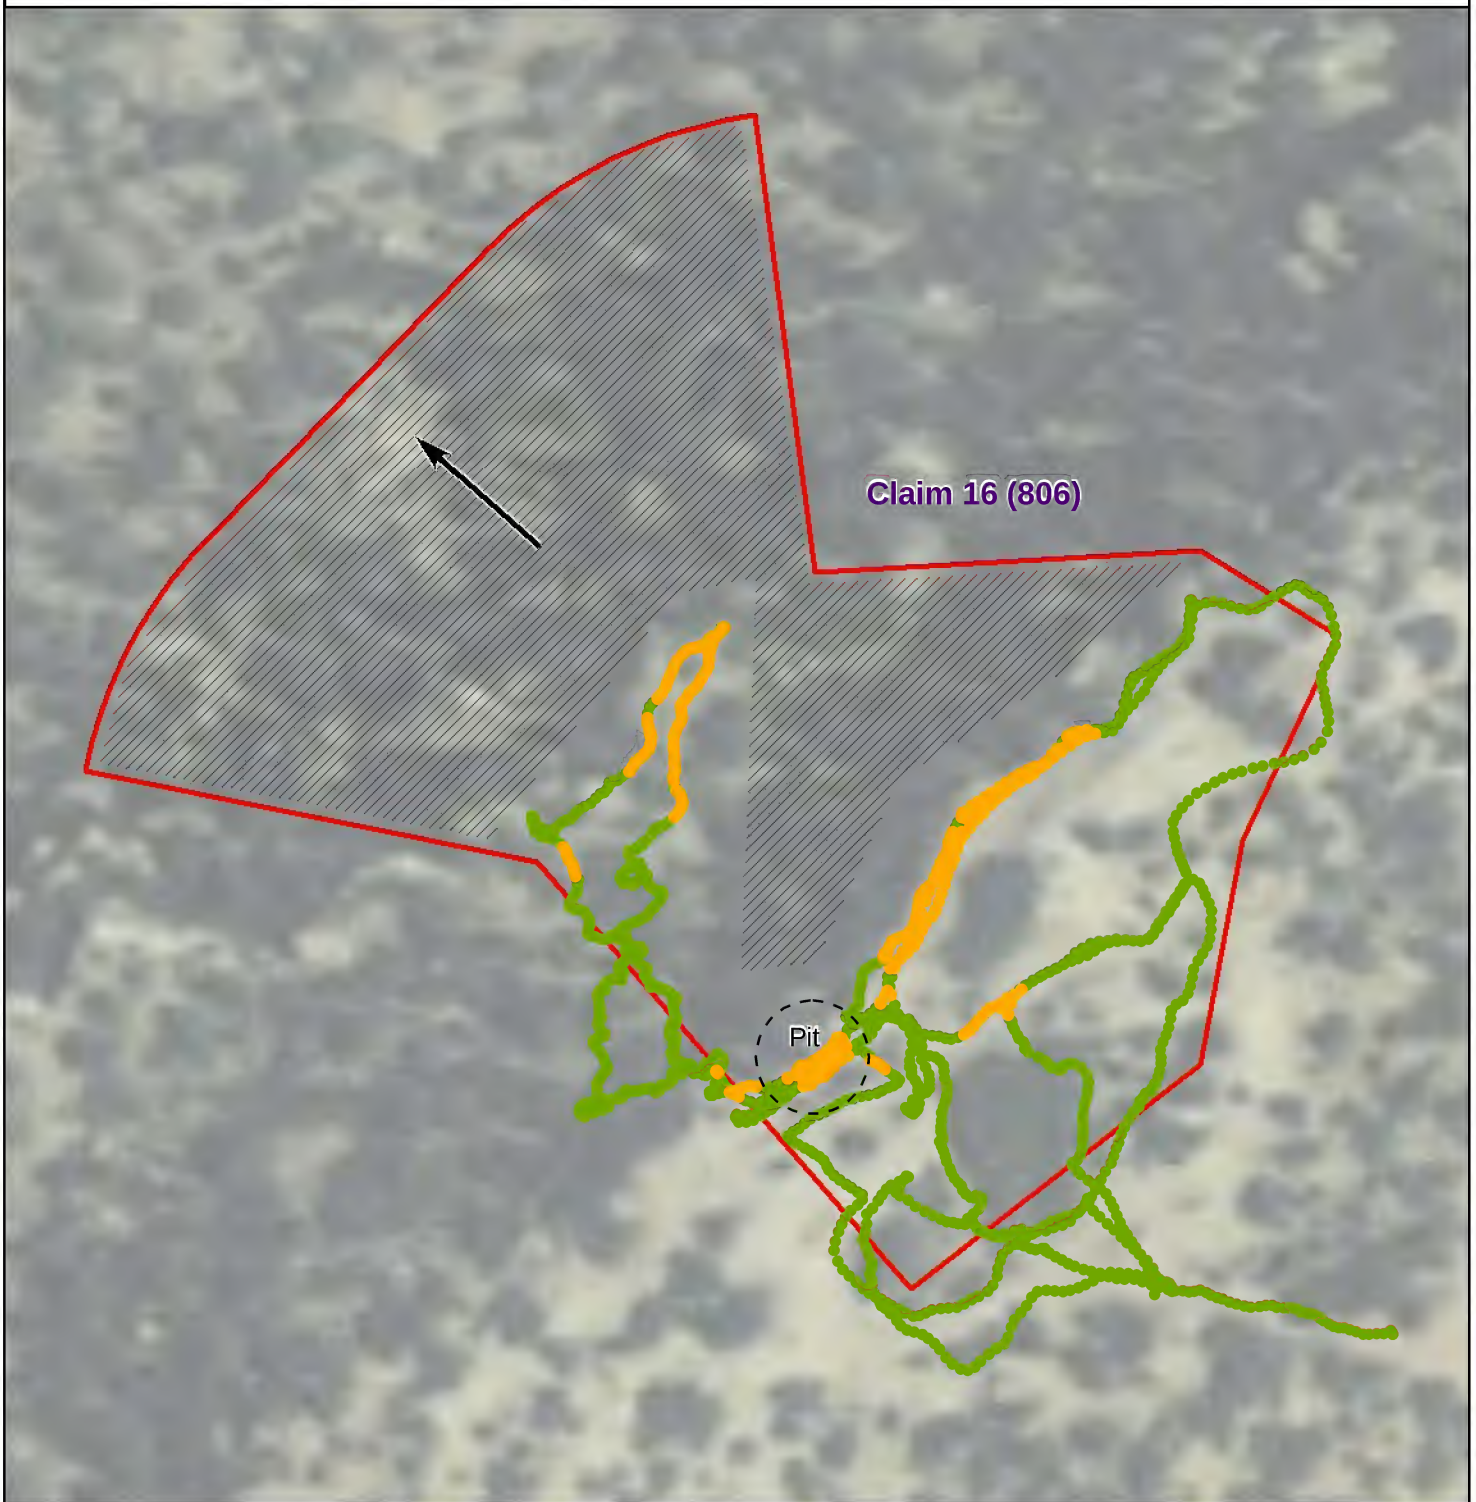
**Figure 1 - Gamma Radiation Measurements, Above Two Times Background
Claim 16 (806)
Tselani / Black Mesa Chapters, Navajo Nation**

A total of 2,052 gamma radiation measurements were collected from the mine site, ranging from 9,770 cpm to 421,288 cpm. Measurements collected in the vicinity of the depression were found at a maximum level of approximately 150,000 cpm. The measurements are represented in Figures 1 and 2.

Average background 13,407 cpm

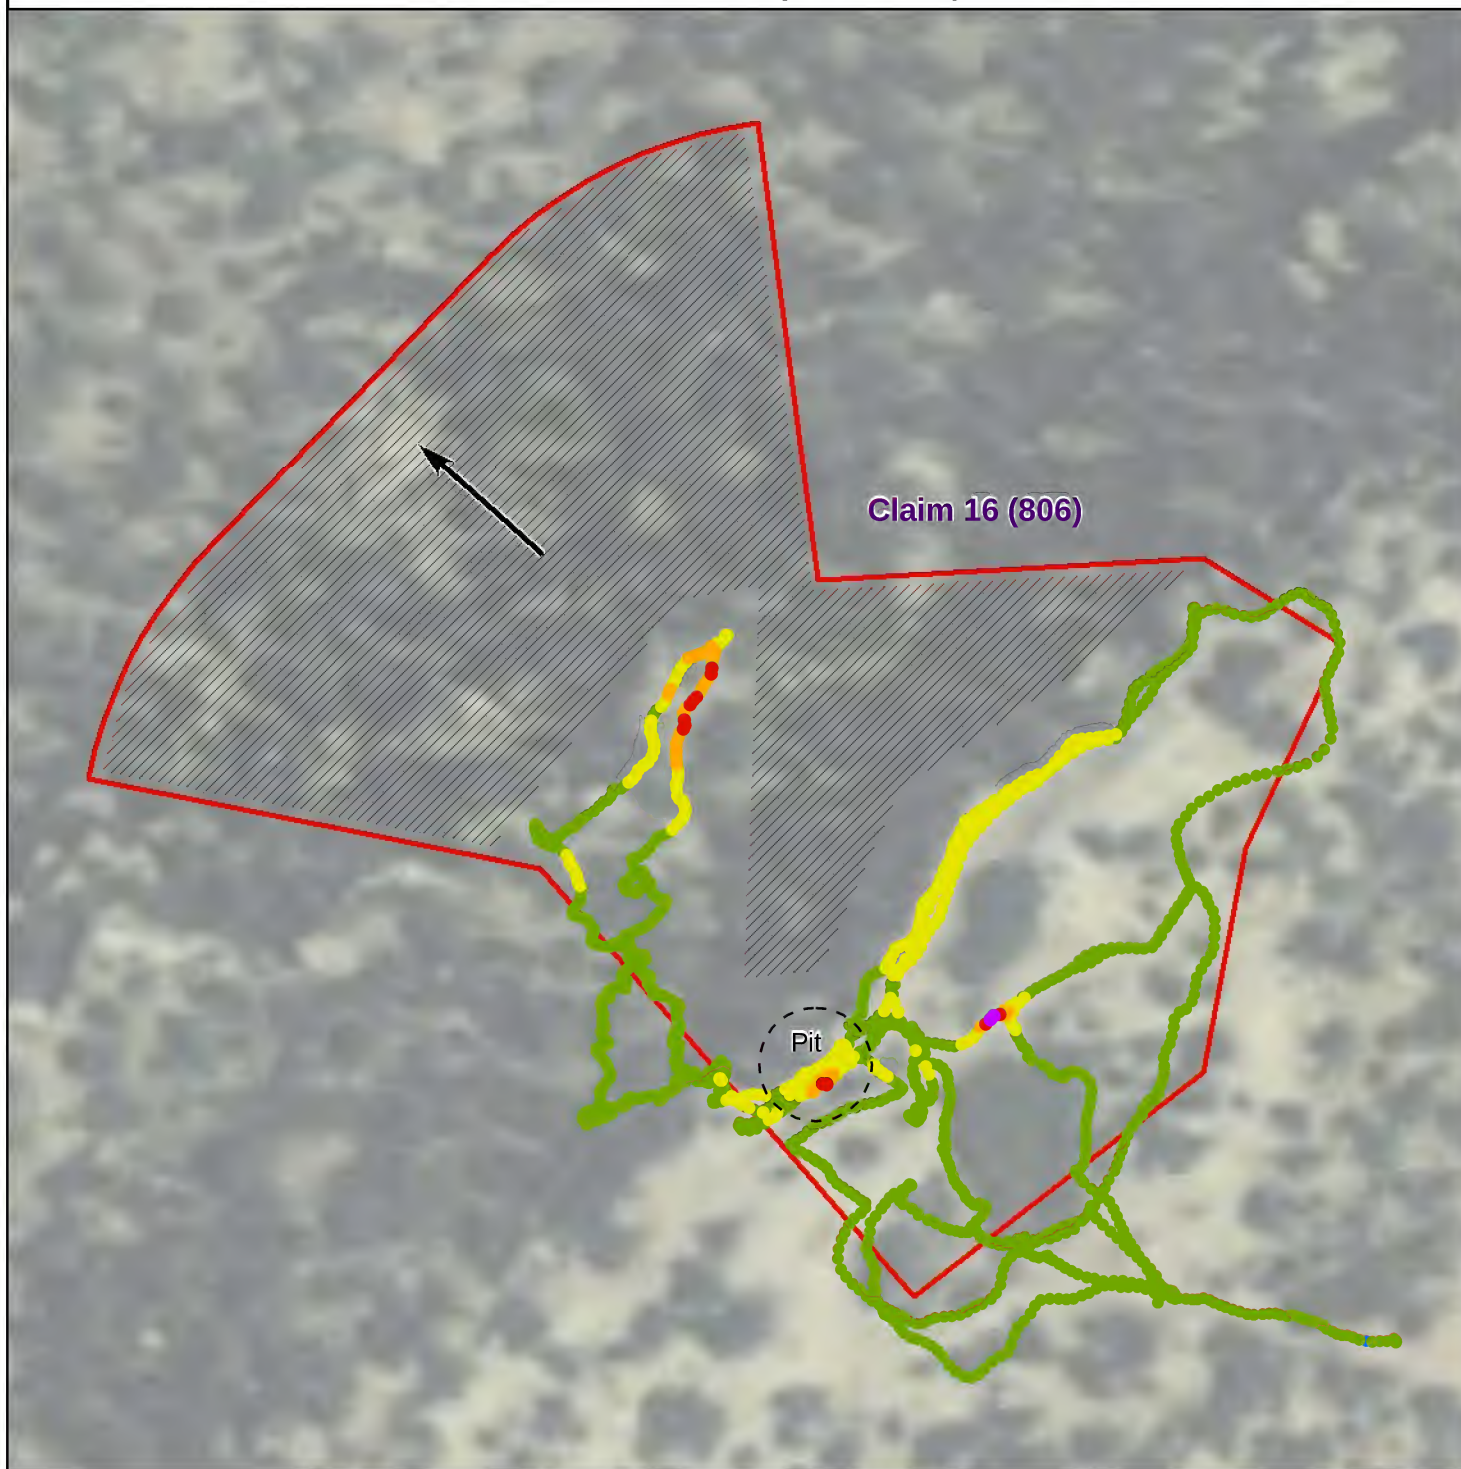
Figure 2 - Gamma Radiation Measurements
Claim 16 (806)
Tselani / Black Mesa Chapters, Navajo Nation

Measured as counts per minute (cpm) Average background 13,407 cpm
